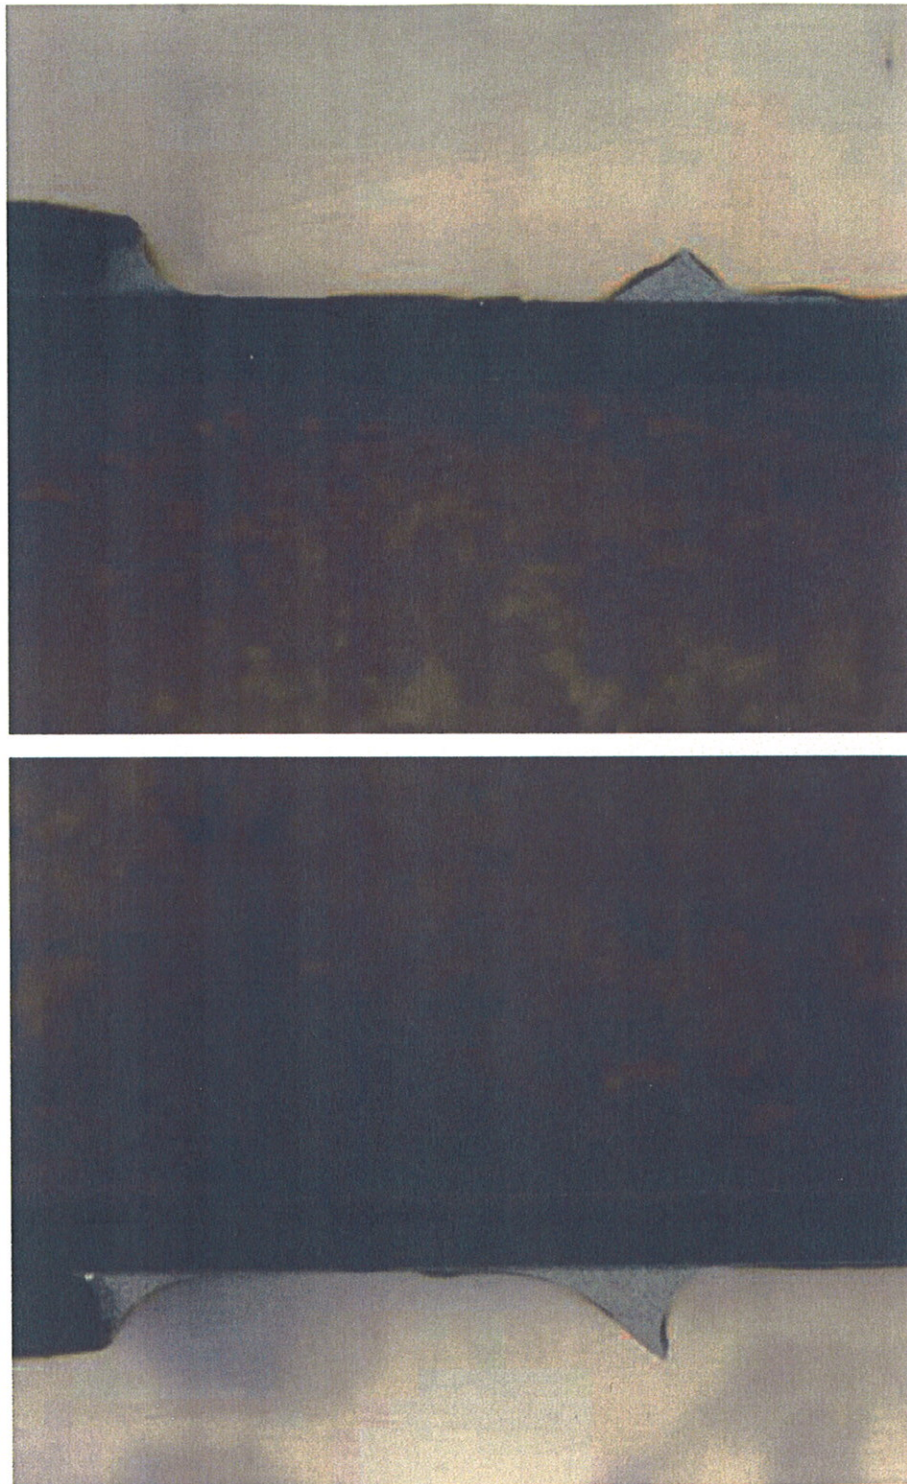
Figure 14. Stereomicroscope images of the polished cross-section of Joint Section 1 showing the solder ridge at higher magnification.

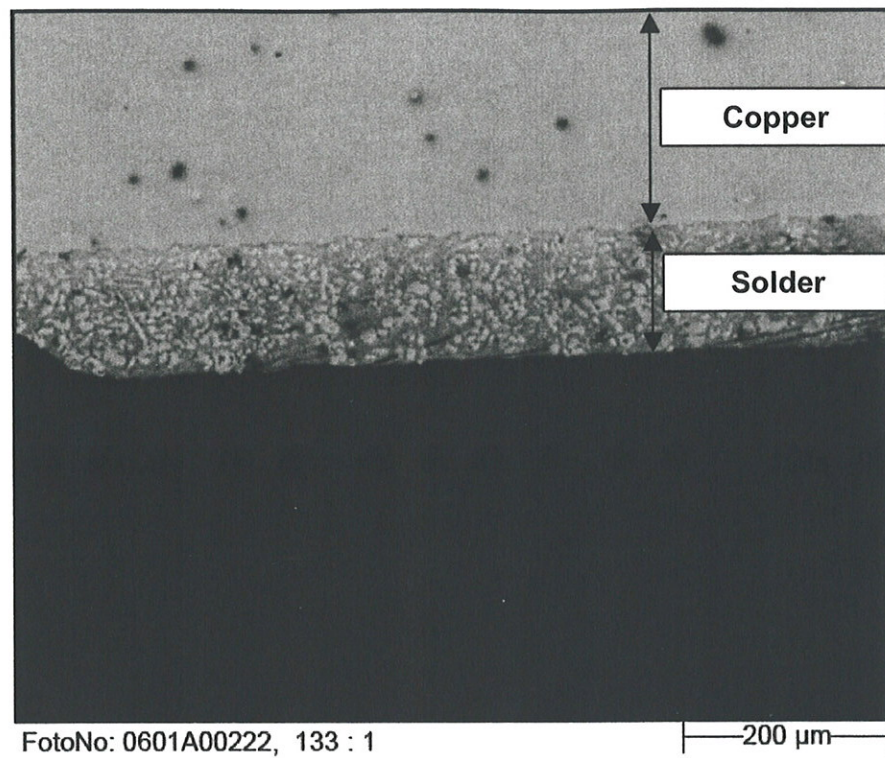
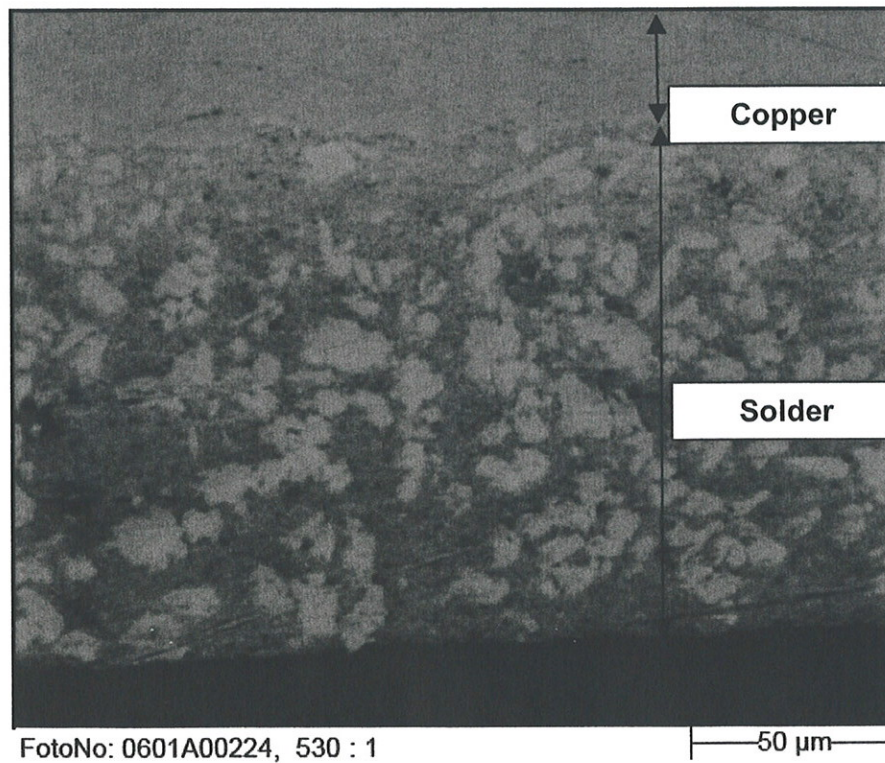
Figure 15. Optical photomicrographs showing the amount of solder remaining on the copper tube surface of Joint Section 1.

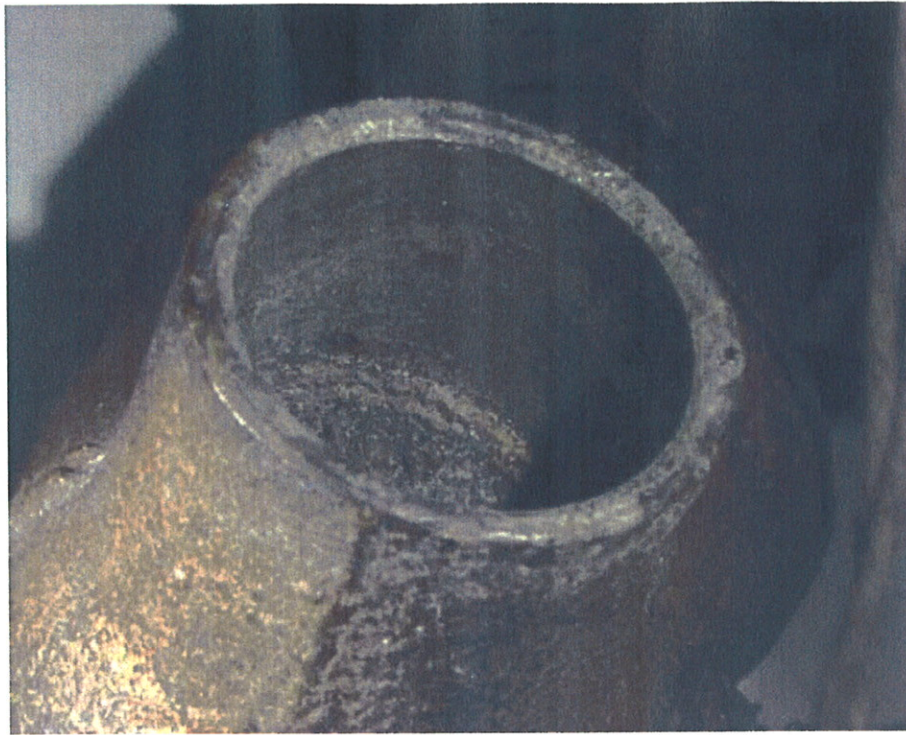
Joint Section 2 refers to the female brass valve fitting that was soldered to Joint Section 1. A stereomicroscope image of Joint Section 2 is shown in Figure 16. An SEM image of the inner surface of Joint Section 2 is shown in Figure 17. The red box in this image denotes the region where EDS analysis was performed on this surface. The spectrum acquired from this EDS analysis is shown in Figure 18.

Figure 16. Stereomicroscope image of Joint Section 2.

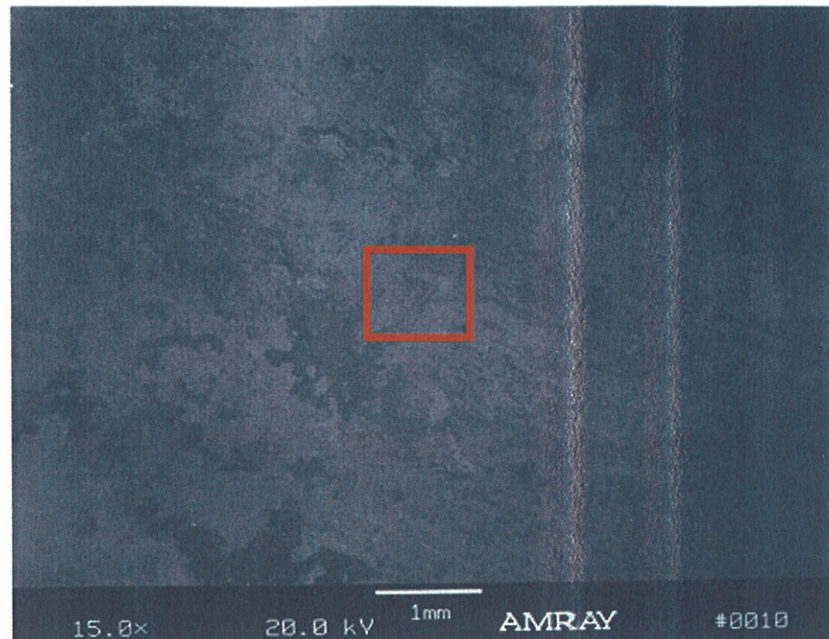
Similar to the corresponding surface of Joint Section 1, the EDS analysis shows the presence of carbon and oxygen on the surface. As with Joint Section 1, it is likely that this carbon and oxygen is a result of soot and oxides that accumulated on the surface during and after the fire. The metals detected include tin, copper, aluminum and lead. All of these elements except aluminum are present in the solder and/or the brass alloy. A discussion with the SEM operator at MMR revealed that the aluminum is likely an artifact of the aluminum sample holder and not the sample itself.

Figure 17. Backscattered SEM image of the inner surface of Joint Section 2. An EDS spectra of the region denoted by the red box is shown in Figure 18.
